Mock Inspection Report

Performed by **George Rapciewicz, CSLB #941548**

This is a mock inspection report to demonstrate that the inspector has performed an inspection according to the [InterNACHI® Standards of Practice](#).

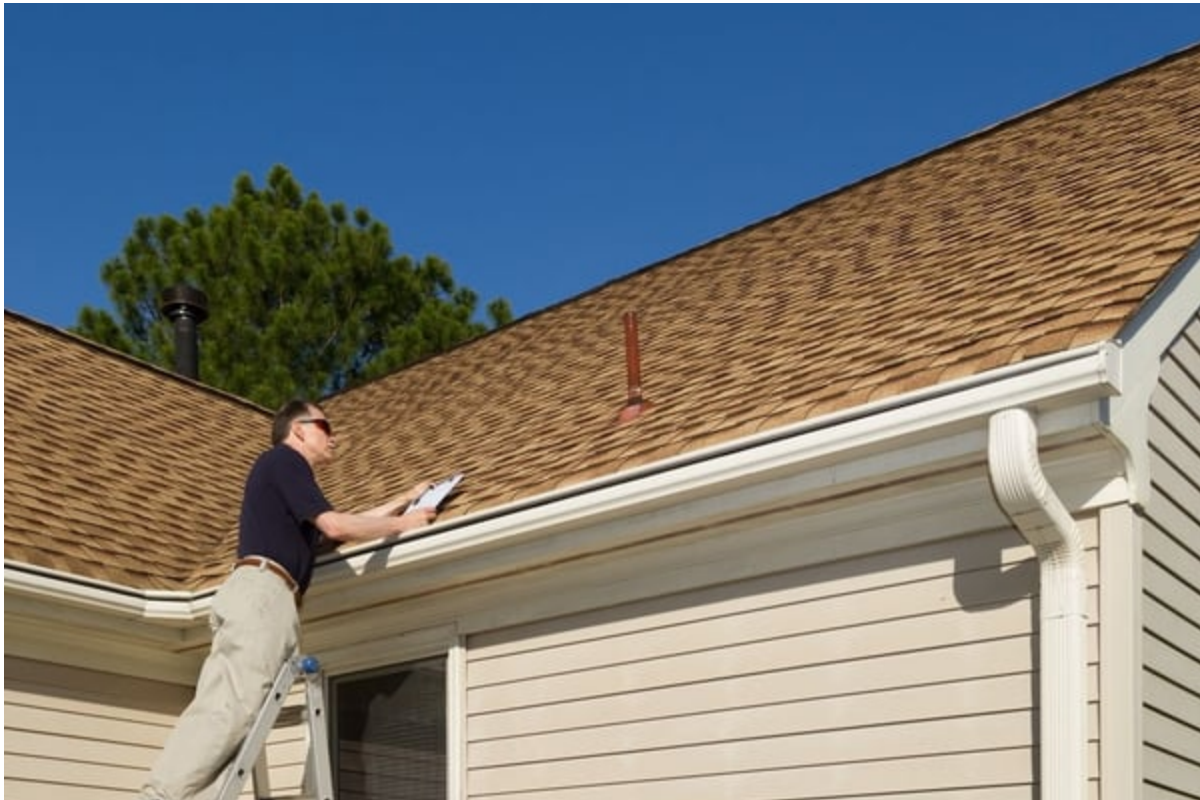
Roof-Covering Materials

No Defect(s) Observed

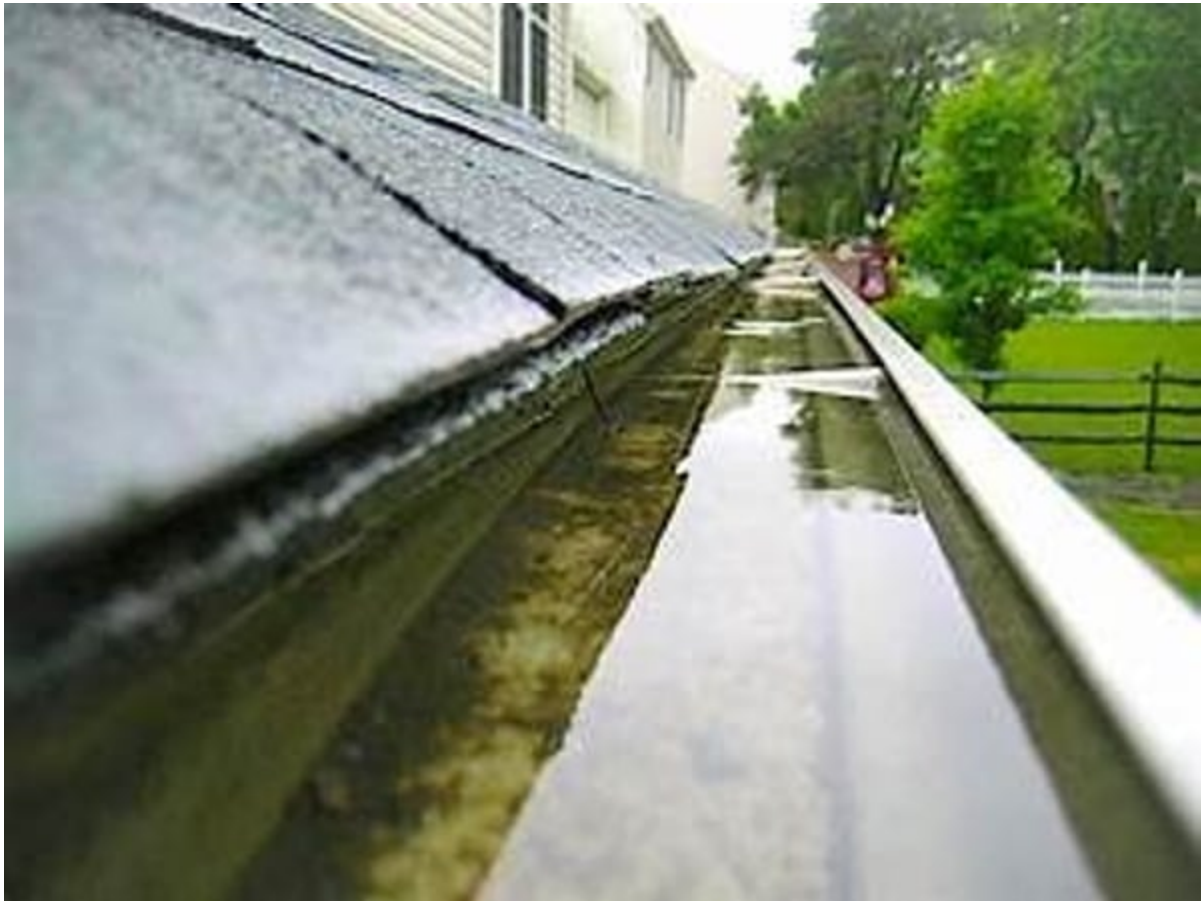
Gutters

No Defect(s) Observed

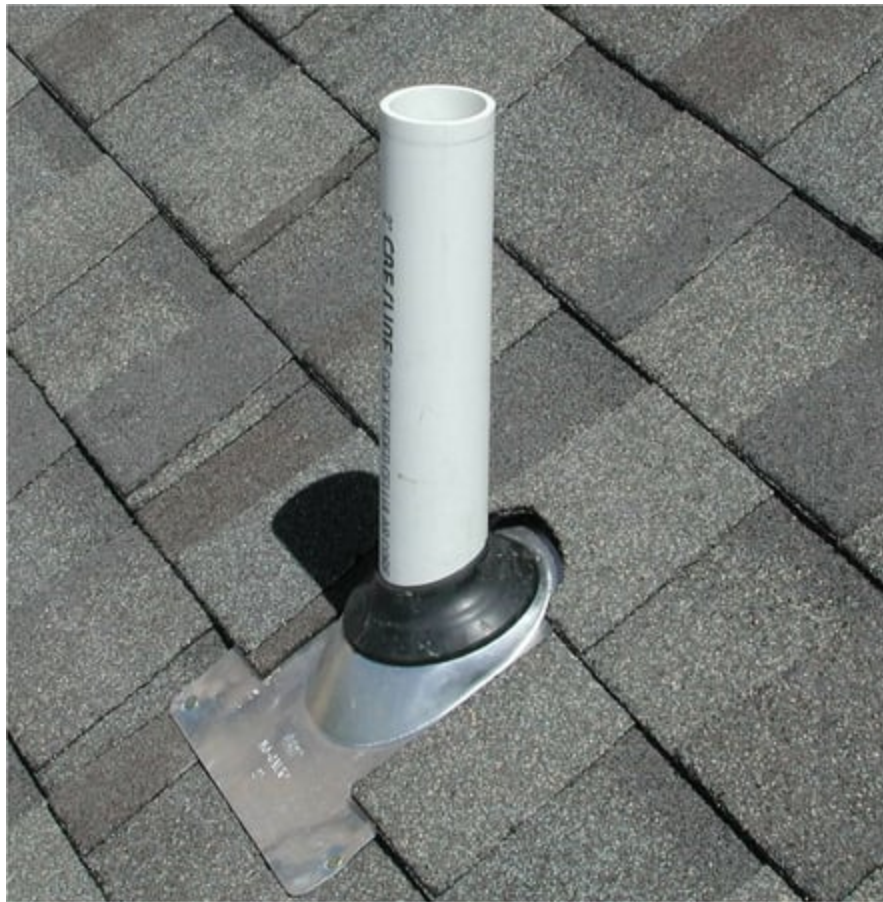
Vents, Flashing, Skylights, Chimney, and Other Roof Penetrations

No Defect(s) Observed

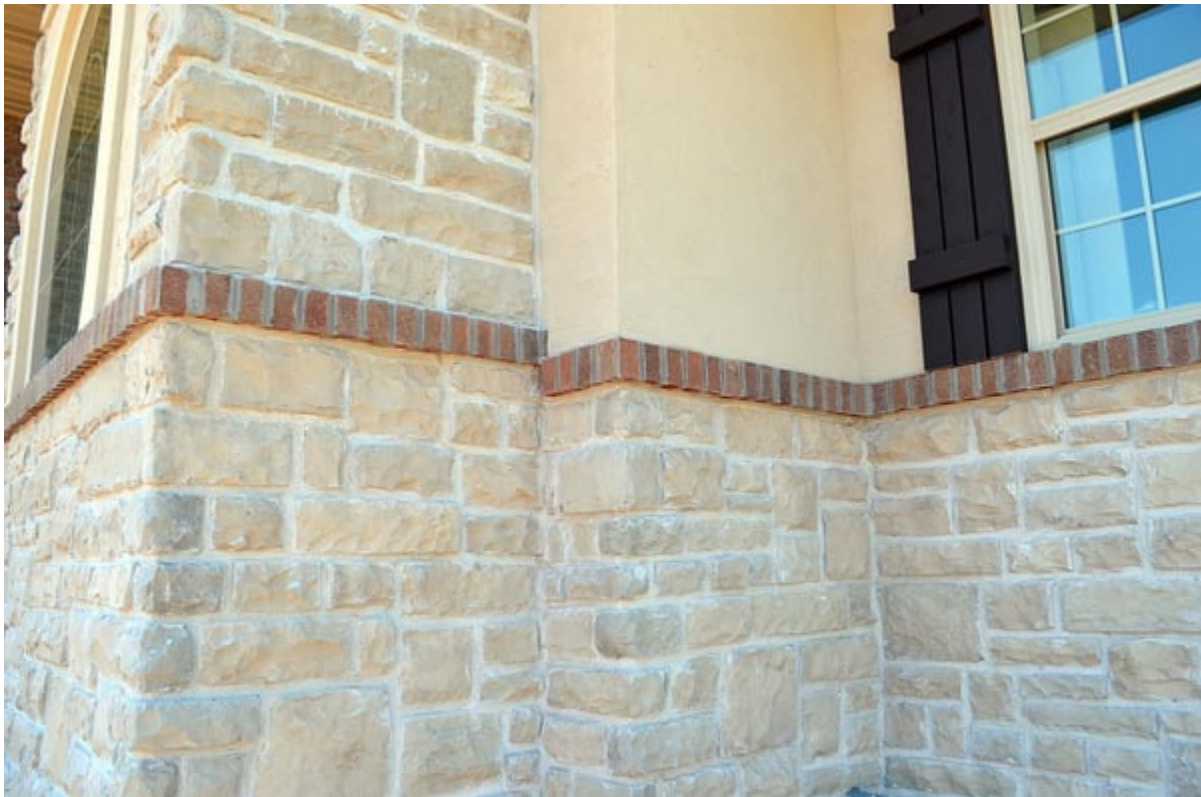
Exterior Wall-Covering Materials

No Defect(s) Observed

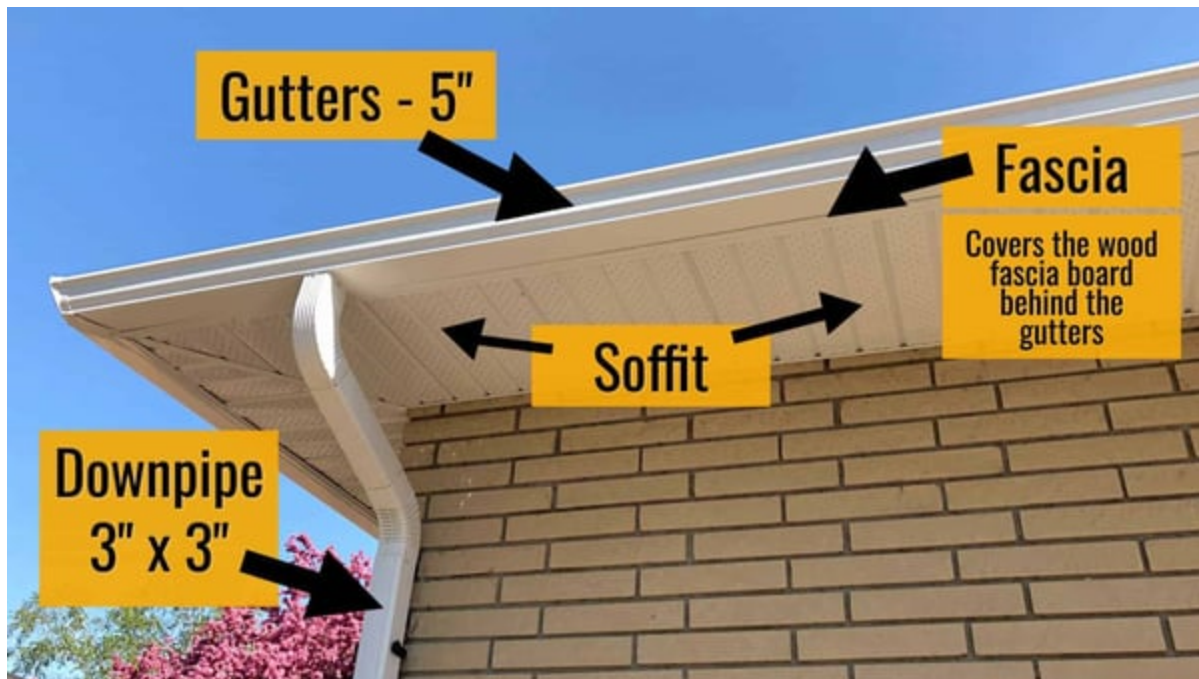
Eaves, Soffits and Fascia

No Defect(s) Observed

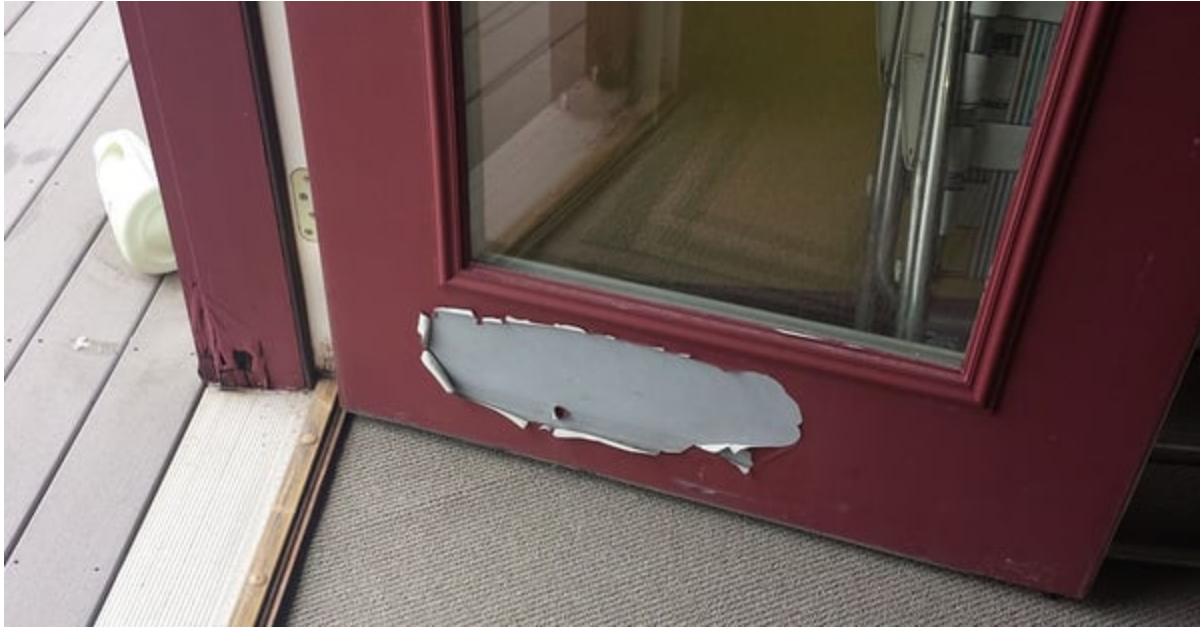
All Exterior Doors

Minor Defect

Frame minor rot. Needs correction. Paint falling off. Needs correction.

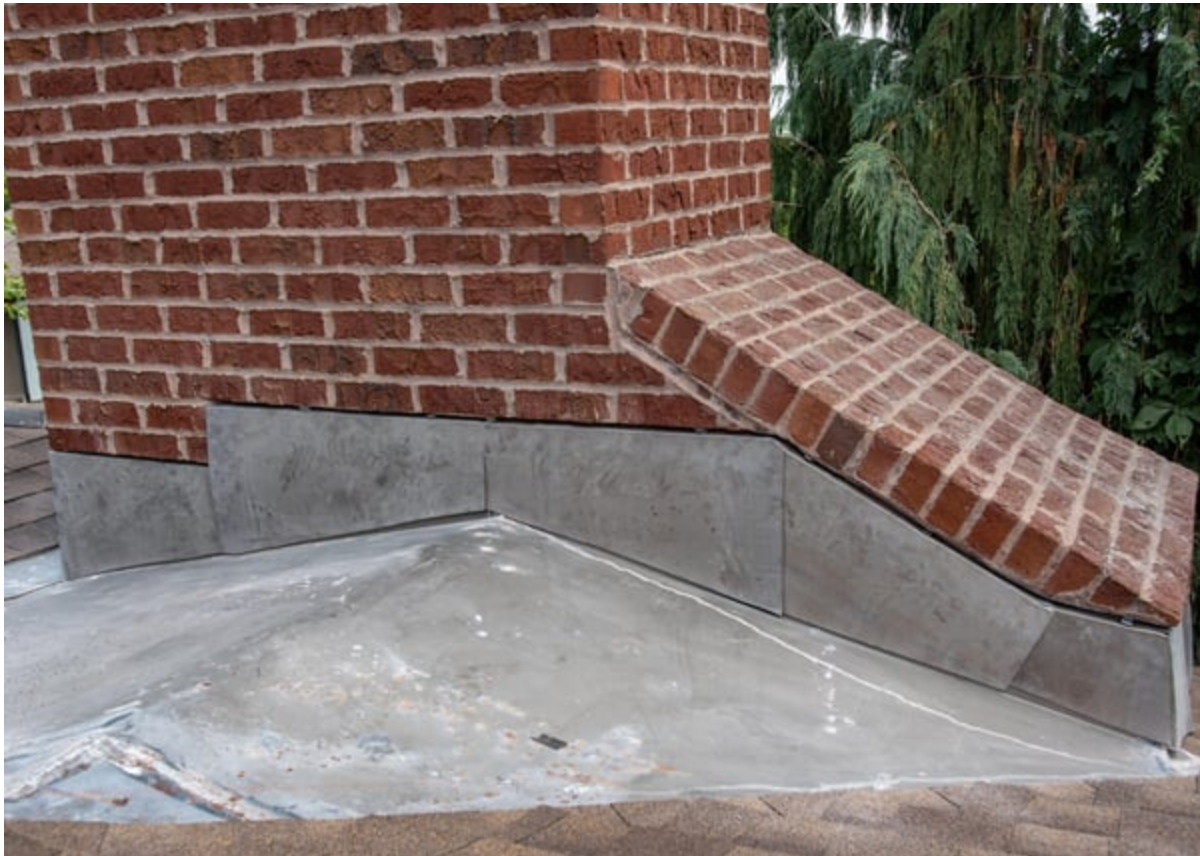
Flashing and Trim

No Defect(s) Observed

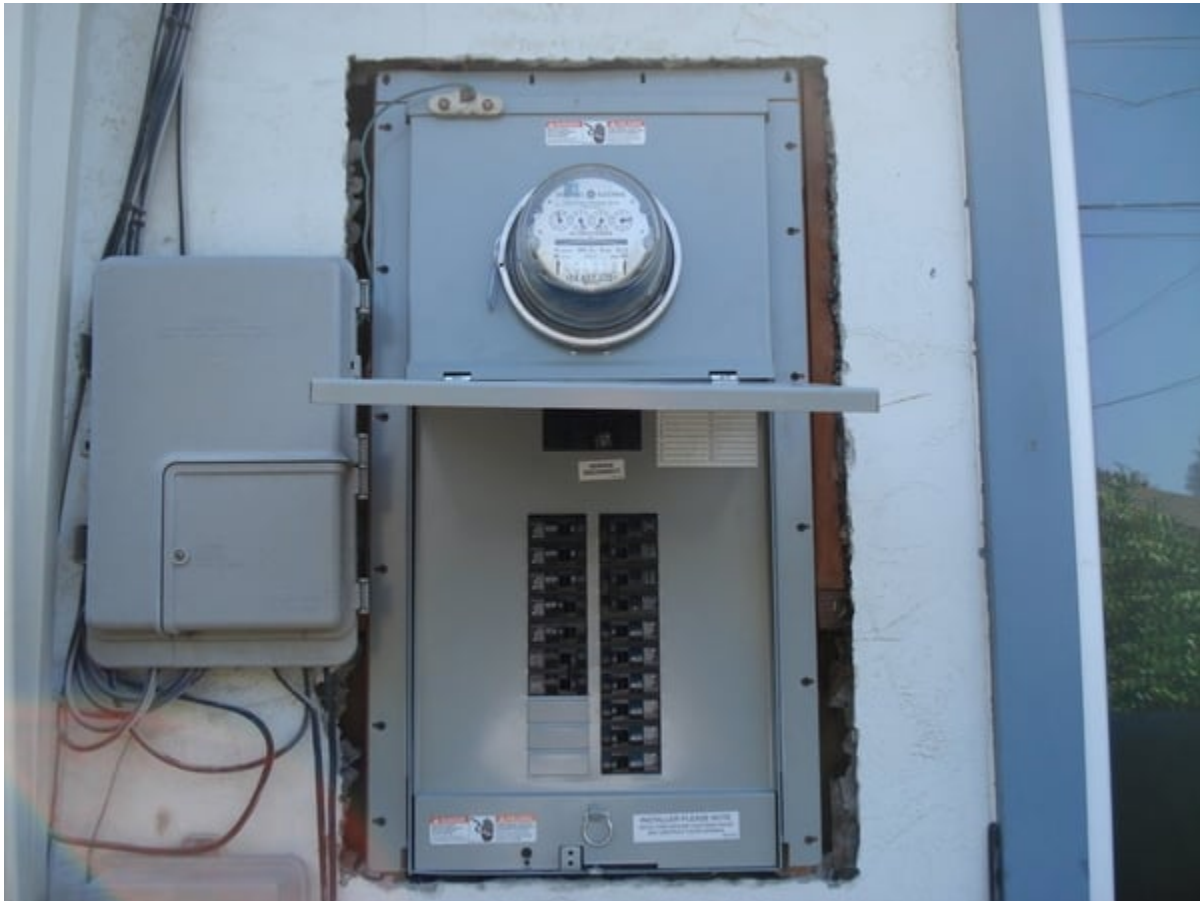
Electric Meter and Base

No Defect(s) Observed

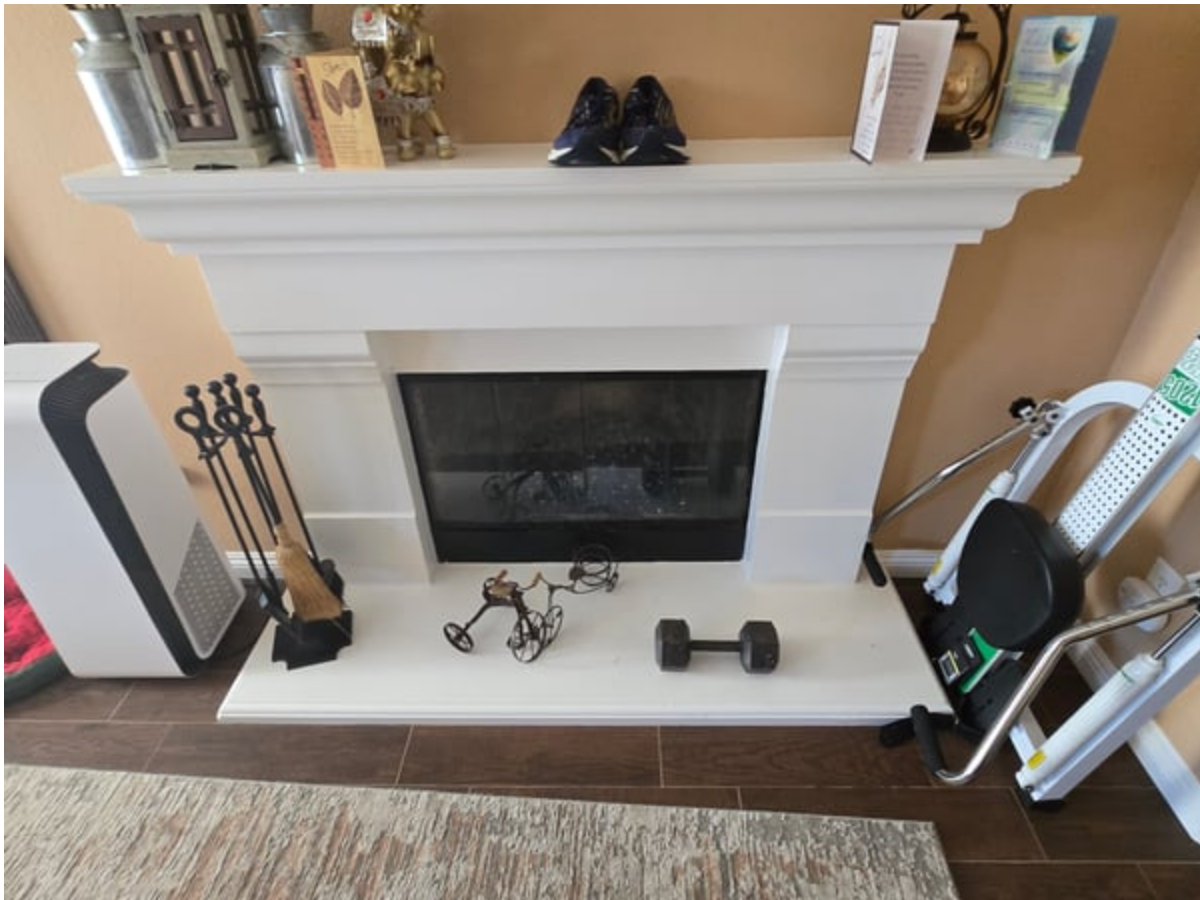
Fireplaces and Chimneys (readily accessible and visible portions)

No Defect(s) Observed

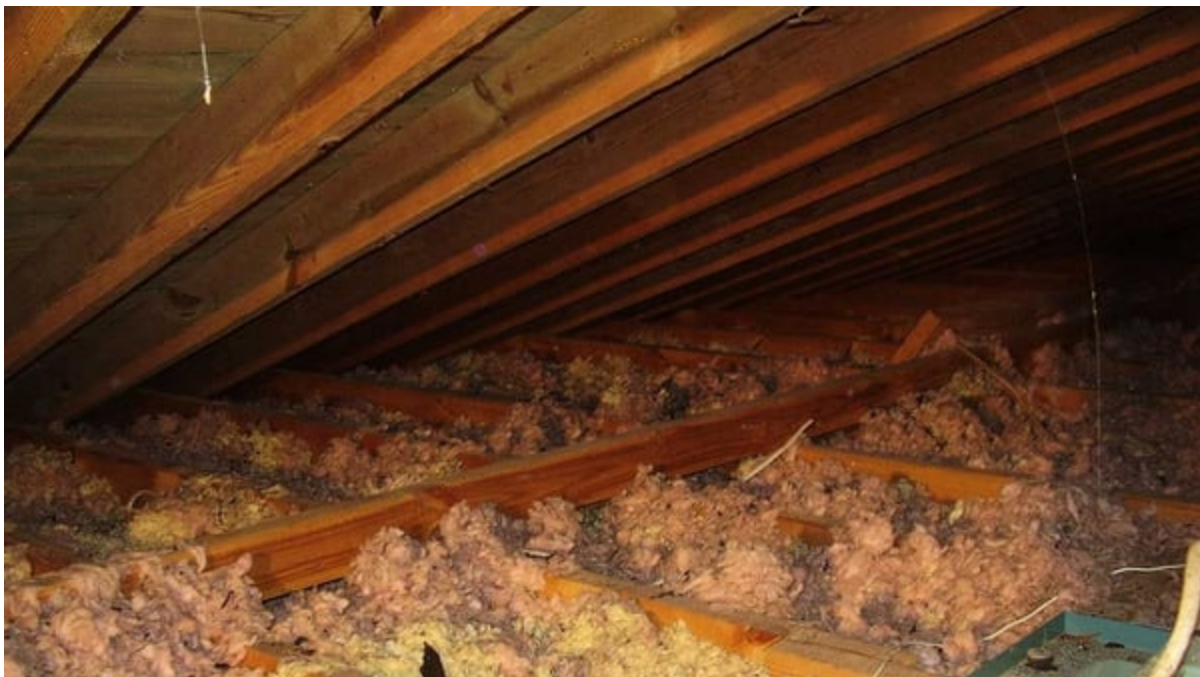
Insulation in Unfinished Spaces (including attics, crawlspaces and foundation areas)

No Defect(s) Observed

Insulation is 5 inches deep

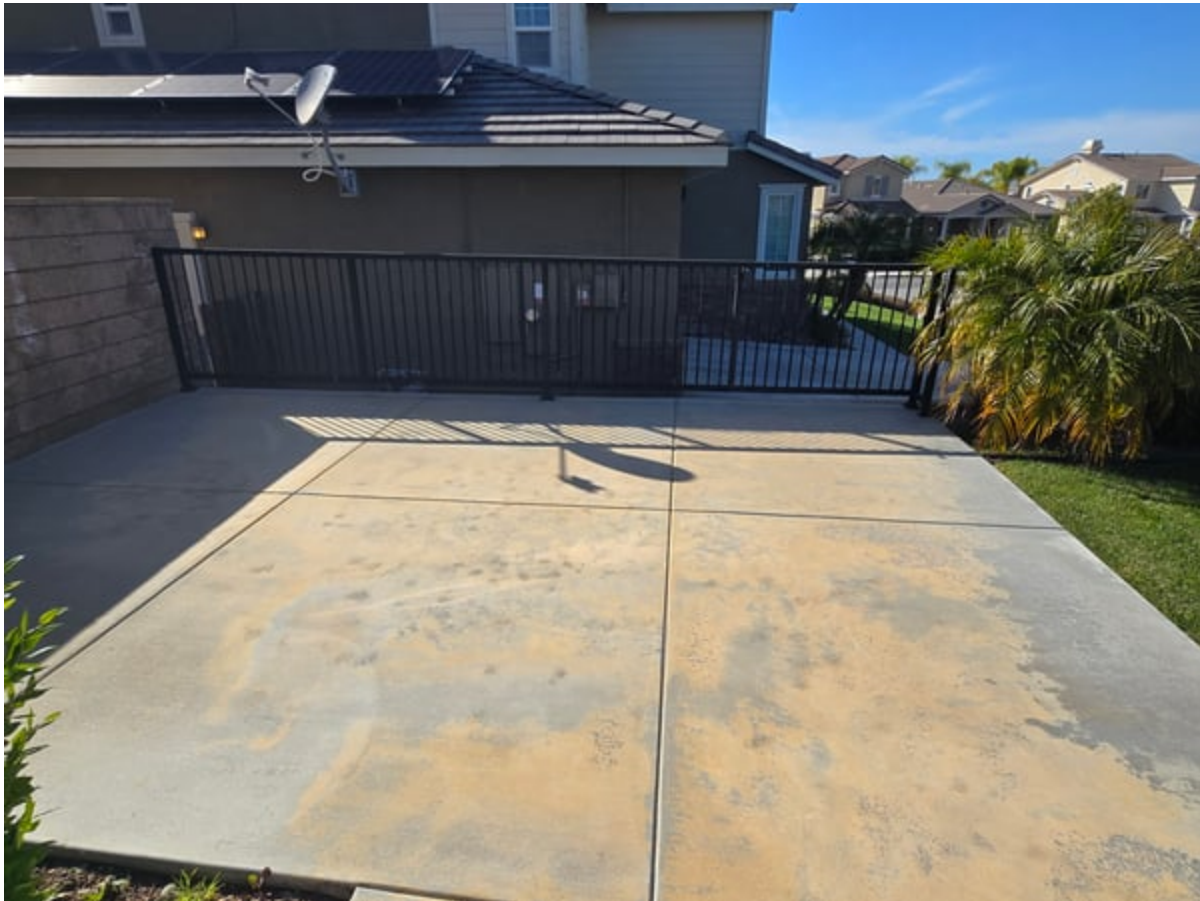
Stairs, Steps, Landings, Stairways and Ramps

No Defect(s) Observed

Exterior rail installed right side of home due to new concrete and 3 foot drop. Rail is made of steel and powder coated.
